Proposal of Bridge Features for Advanced Bridge Health Monitoring System
(橋梁ヘルスマニタリングシステム高度化のための橋梁特徴量の提案)

Principal Investigator: Dr. Gen HAYASHI,
Asst. Professor, Osaka Metropolitan University
研究代表者 大阪公立大学大学院工学研究科 助教 林 厳

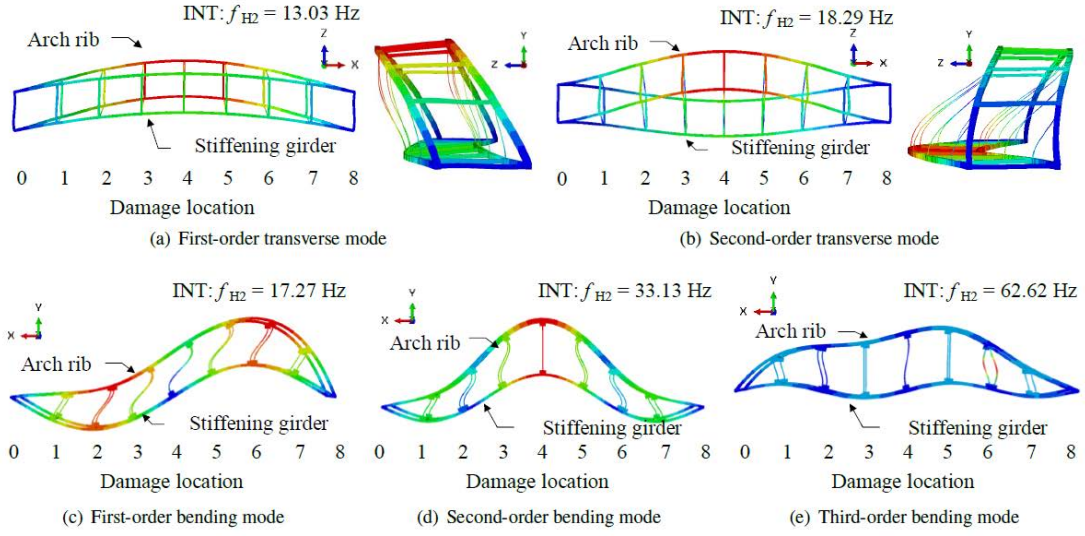
Figure 4 shows the natural frequencies of the first-to third-order bending modes and first- and second-order transverse modes in the intact case (INT) obtained from the analysis, along with the natural frequencies of these modes. Figure 5 shows the mode shapes when Hlb3 was damaged as an example. In this way, it was confirmed that, even with the damages, the mode shapes did not change. Figure 6 shows the damage location and difference between the natural frequencies of the intact and damaged cases. The

Figure 4 Natural vibration modes

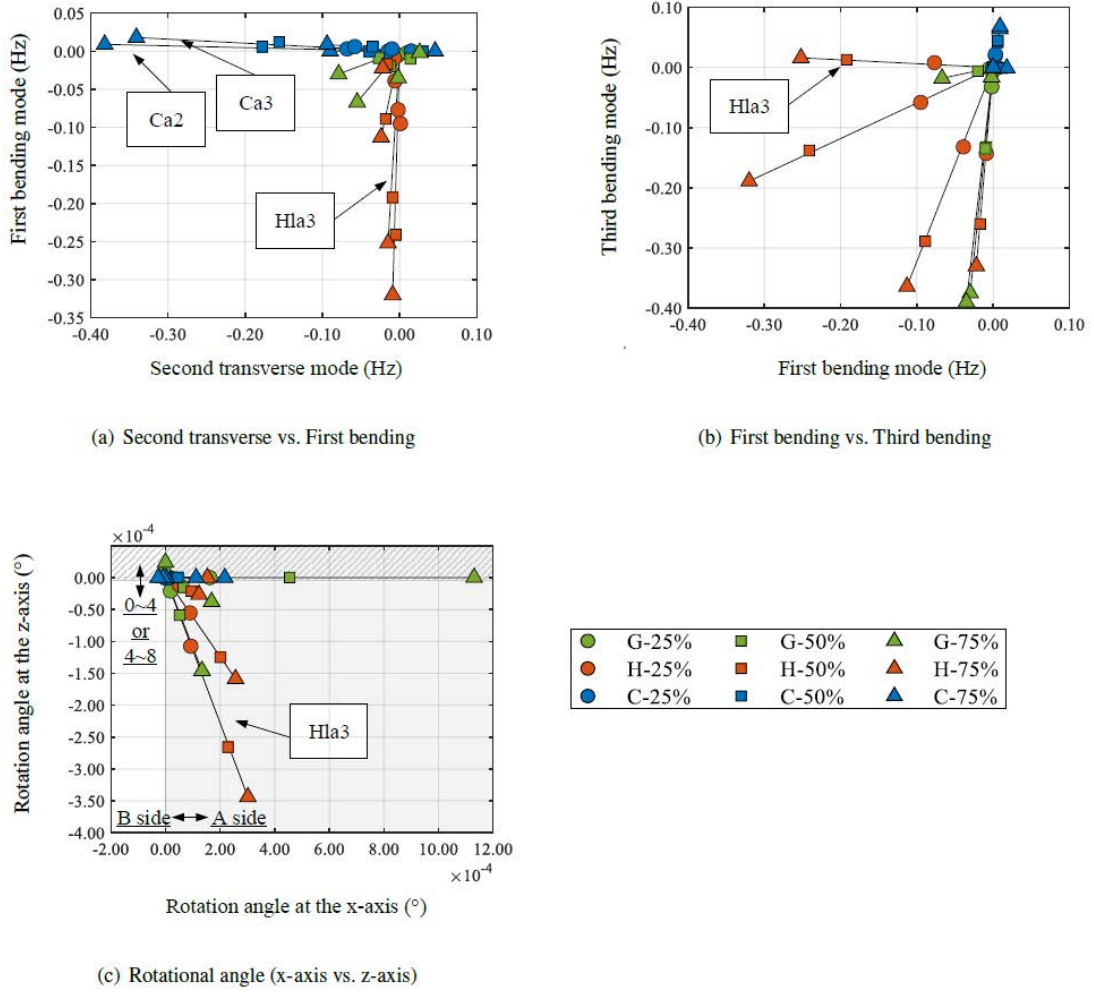
Figure 9 presents the natural frequencies of the second-order transverse, first-order bending, and third-order bending modes, as well as the differences in rotation angles. In these figures, only damages at positions 0-4 of the A girder were considered. The damage levels taken into account were 25%, 50%, and 75%.

In Figure 9(a) and (b), the axes indicate the difference in frequency from the intact case for each natural-order bending mode in the damaged case. Specifically, Figure 9(a) shows the second-order transverse mode on the horizontal axis and the second-order bending mode on the vertical axis. In Figure 9(b), the second and third-order bending modes are on the horizontal and vertical axes, respectively.

Finally, the axes in Figure 9(c) represent the difference in rotation angle relative to the intact case. The rotation angle in the longitudinal direction (x-axis) is shown on the horizontal axis, and that in the transverse direction (z-axis) on the vertical axis.

In all figures, the damaged members are represented by the colour of the plot (green for stiffening girders, orange for hanger members, and blue for cross girders), and the damage level is indicated by the marker shape (\bigcirc for 25%, \square for 50%, and \triangle for 75%). The solid lines in the figure connected the points at the intact condition (0%) and 75% damage level.

Figure 9 Relationship between damaged members / damage degree and natural frequencies / rotational angle

First, focusing on the relationship between the second-order transverse mode and first-order bending mode, we can discern from Figure 9(a) that the damage to Ca2 and Ca3 in the cross-girder causes significant changes in the x-axis direction, even though some damage points near the origin may appear indistinguishable. Damage to the hanger members induces variations in the y-axis direction, whereas that to the

stiffening girders causes changes in the direction oriented 45° . Given these relationships, it is possible to estimate the damage location.

The relationship between the first- and third-order bending modes, as depicted in Figure 9(b), implies that the angle to the x-axis differs depending on the location of the hanger member damage. Hence, it may be possible to estimate the damage location based on this relationship.

Furthermore, the relationship between the rotation angles in Figure 9(c). In this figure, the rotation angle was positive around the x-axis and negative around the z-axis because the damaged member was located at damage locations 0-4 of girder A.

Distinctions among the damage levels were made evident by the near-linear alignment of plots for the three predefined damage levels in this study. This indicates that regardless of variations in the damage level, the damage to each member manifests in a specific natural frequency mode. Furthermore, the degree of change in the natural frequency increases with the damage level.

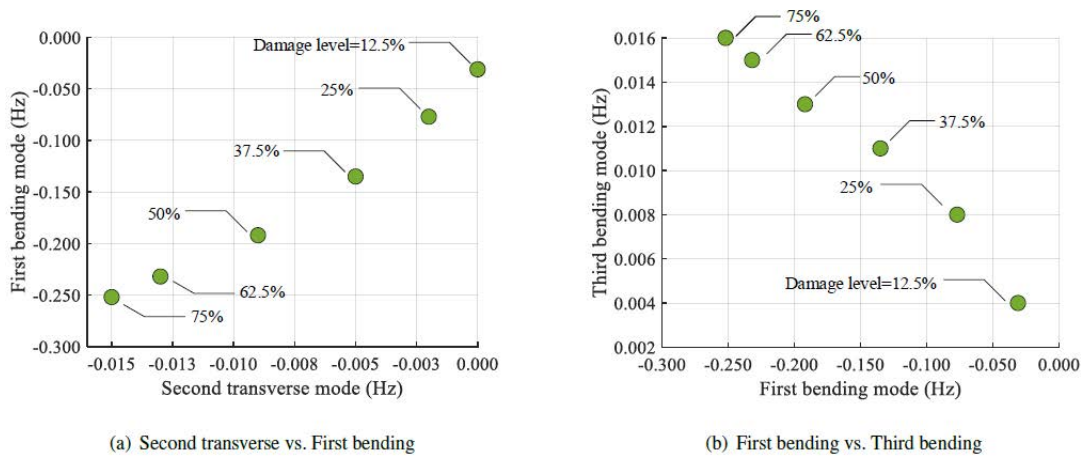
Figure 10 presents the results of a damage analysis conducted to further elucidate the relationship between damage level and the change in natural frequency. We focused on H1a3, for which a slight deviation from linearity was observed upon damage, as shown in Figure 10(a). The analysis was conducted at seven different damage levels: 6.25%, 12.5%, 25%, 37.5%, 50%, 62.5%, and 75%. The axes in the figures shown in Figure 10 represent the difference in the natural frequency relative to the intact condition, similar to Figure 8(a) and (b).

Figure 10 Relationship between damage degree and natural frequencies in H1a3

In both Figure 10(a) and (b), it can be observed that the change in natural frequency maintains an almost linear that it may be possible to predict damage at unknown levels using natural frequencies.

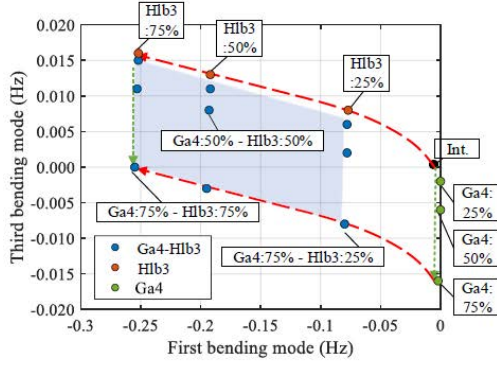
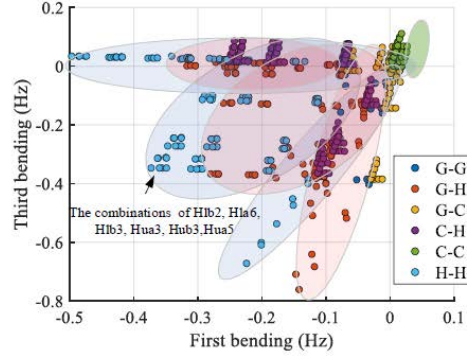
(a) Single/multiple damage of stiffening girders

(b) 3-D distribution of natural frequencies of damaged cases

(c) Second transverse vs. First bending

(d) First bending vs. Third bending

(e) Second transverse vs. Third bending

Figure 11 Differential natural frequencies for each vibration mode in multiple damage cases

The results of plotting the differences in natural frequencies for each vibration mode in the multiple damage cases, as presented in Figure 2, are shown in Figure 11.

From Figure 11(a), it is observed that in the cases of singular damage, either Ga4 (green) or Hlb3 (orange), the natural frequency changes linearly with the increasing damage level, as discussed in the Section 3.3. In contrast, in the case of multiple damage instances, when the damage levels of Ga4 and Hlb3 were both 75% (Ga4:75%, Hlb3:75%), the change in natural frequency appeared to be the sum of the differences in natural frequencies between the 75% case for Ga4 damage and that for Hlb3 damage. In essence, in cases of multiple damage, the natural frequency changes in the coloured area of Figure 11(a). Therefore, the superposition of the results from singular damage instances may be utilised to estimate the damaged member and location of the damage. Figure 12 shows the mode shapes when multiple damages occur. From this figure, it is evident that there is minimal change in the mode shapes even when multiple damages occur. From this, it can be inferred, as described in Section 3.1, that the members or positions with significant deformation in each mode shape are the same. In other words, since the components and positions that have a large effect on the natural frequency of each mode are the same as a single damage, the change in natural frequency can be considered as the sum of the effects of individual damage on each mode. This trend was similarly observed for other damages.

Similarly, other members were studied, and the results of the 3D plot are shown in Figure 11(b). The figure indicates the same trend observed for the Ga4 and Hlb3 damage cases applies to other combinations of damage cases, with the distributions clustered on the same plane.

Figure 11(d) illustrates the relationship between the natural frequencies of the first-

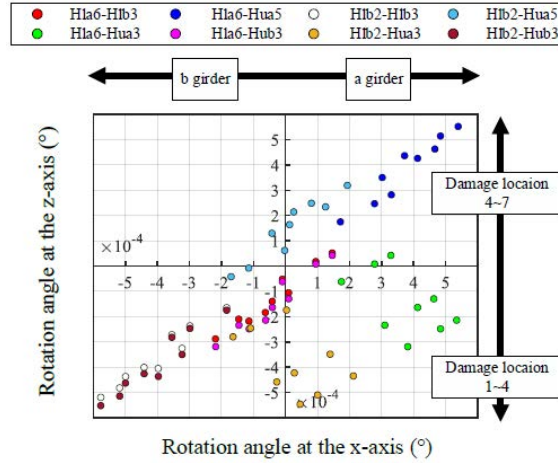
Figure 13 illustrates the change in rotation angle during damage to Hlb2, Hla6, Hlb3, Hua3, Hub3, and Hua5, which proved difficult to classify based on natural frequency due to the symmetry of the damage locations. Positions 2 and 6, as well as 3 and 5, are symmetrical.

Figure 13 Rotation angle at multiple damage

In the figure, the horizontal axis represents the rotation angle at the x-axis, the vertical axis represents the rotation angle at the z axis, and the colours of the markers indicate different combinations of damage.
